OVERVIEW OF SELECTED STRUCTURAL FAILURES

Ric Leist, PE

15 June, 2023

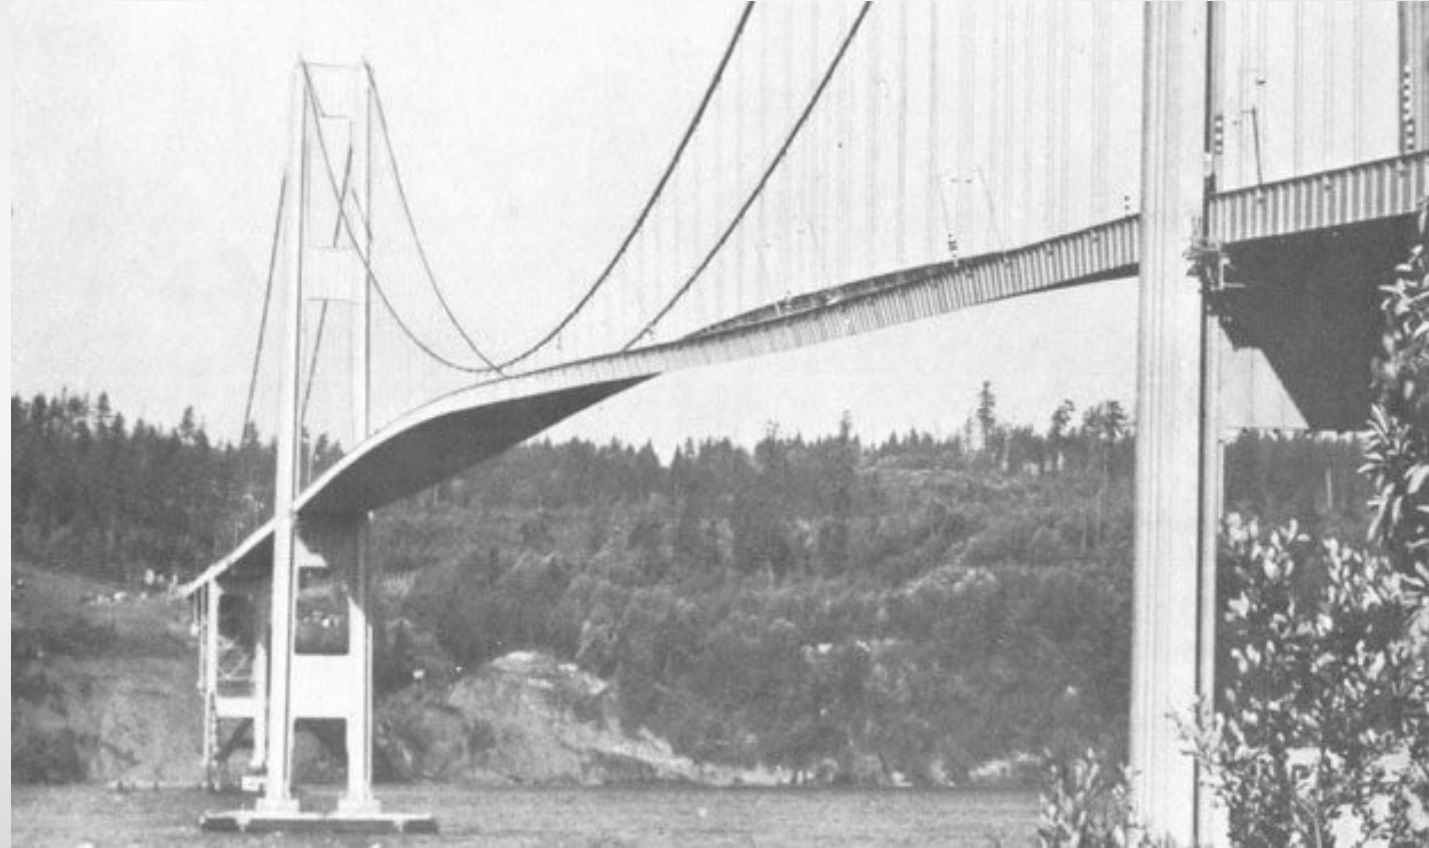
Tacoma Narrows Bridge 1940

- No fatalities / injuries
- Lasted quite a while
- Relatively new bridge (4 mo)
- Causes:
 - Did not consider vortex shedding in crosswinds
 - Not stiff enough for bending or torsion
 - Final cause failed in fatigue

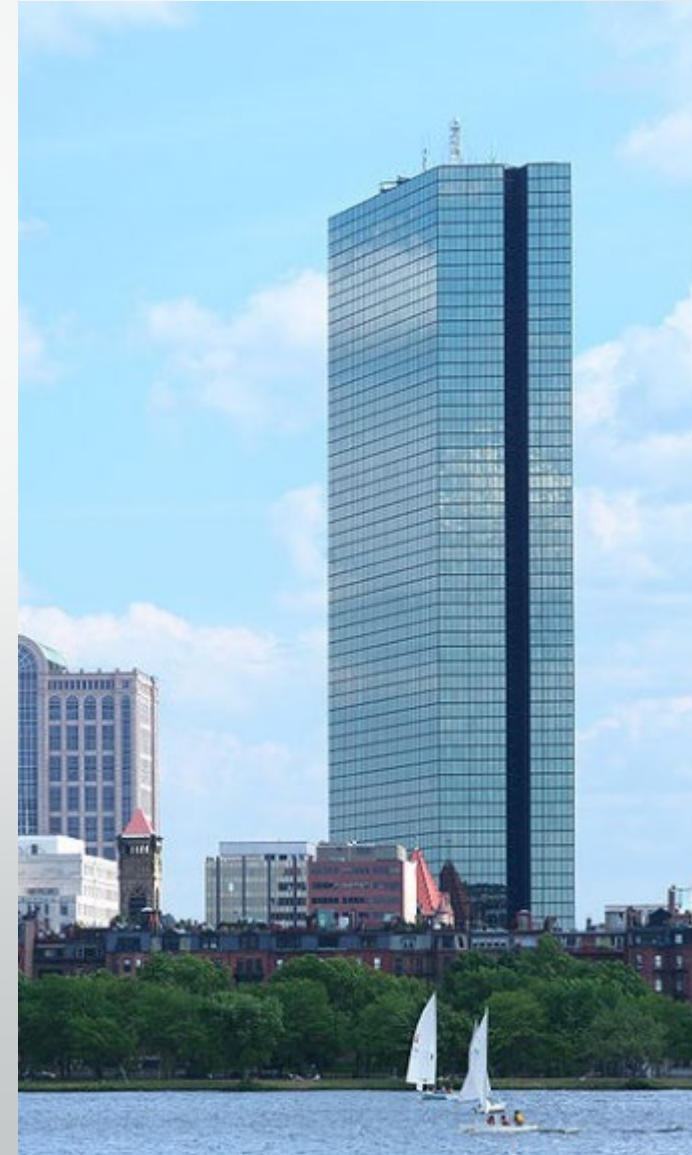
John Hancock Tower, Boston 1973

- **Issues since built in 1973**
- **Windows popped out of structure twice**
- **No fatalities / injuries**
- **Causes:**
 - **Building flexible and sways due to crosswinds**
 - **Another factor, thermal variation put stress on metal coated windows**
 - **Solution was interesting**
 - **Cleared and reinforced 111th floor**
 - **Strain gauged the building**
 - **Installed 11 ton lead mass on rollers that is moved by computer guided hydraulic actuator system based on strain gauge inputs to counterbalance the building deflections**

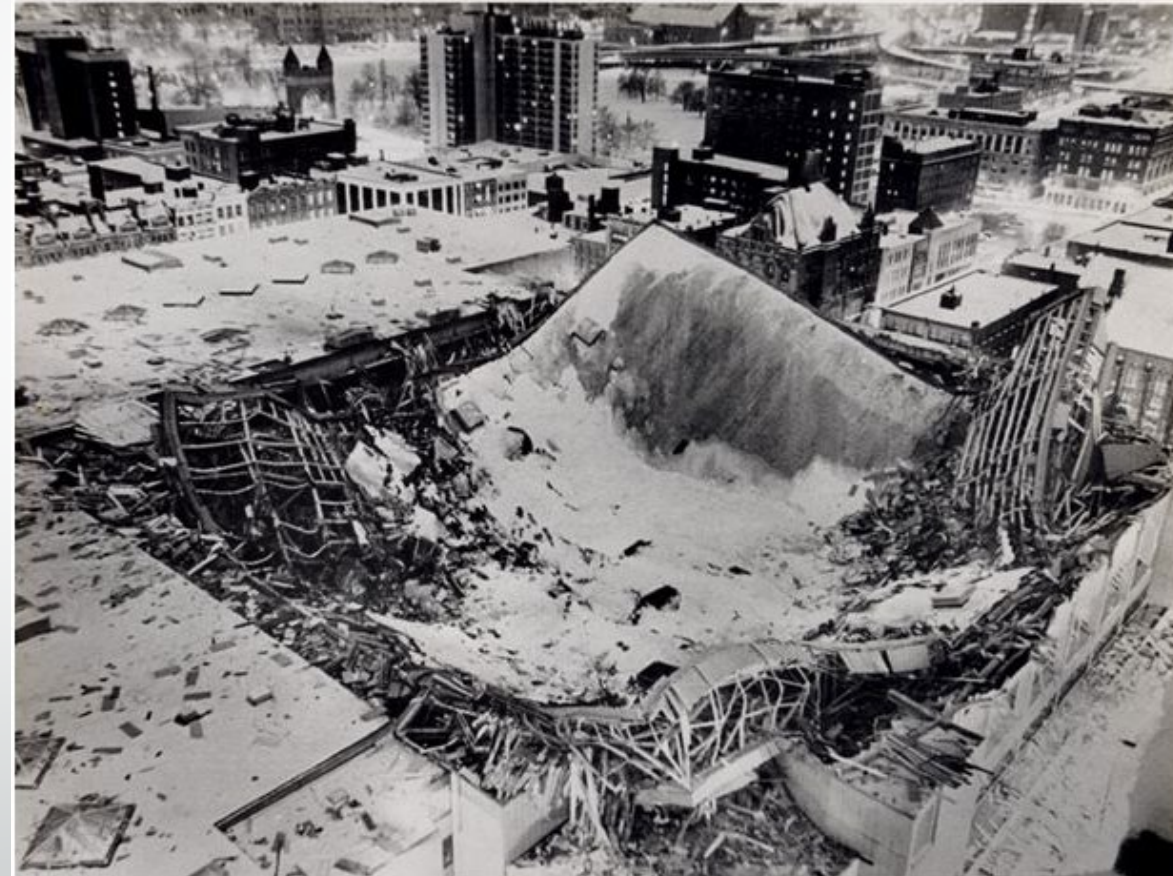
Hartford Connecticut Civic Center Roof 1978

- No fatalities / injuries
- Causes: Many
 - Design used unusual truss configuration
 - Poor torsion section properties (i.e. low rad of gyration)
 - Very buckling sensitive
 - Too much reliance on FEM
 - Some elements were resized but FEM not reanalyzed
 - Miss-estimated structure weight
 - Some details not built as specified
 - Some design features not per AISC code

View of the Hartford Civic Center roof, which collapsed on January 18, 1978 - [Connecticut Historical Society](#)

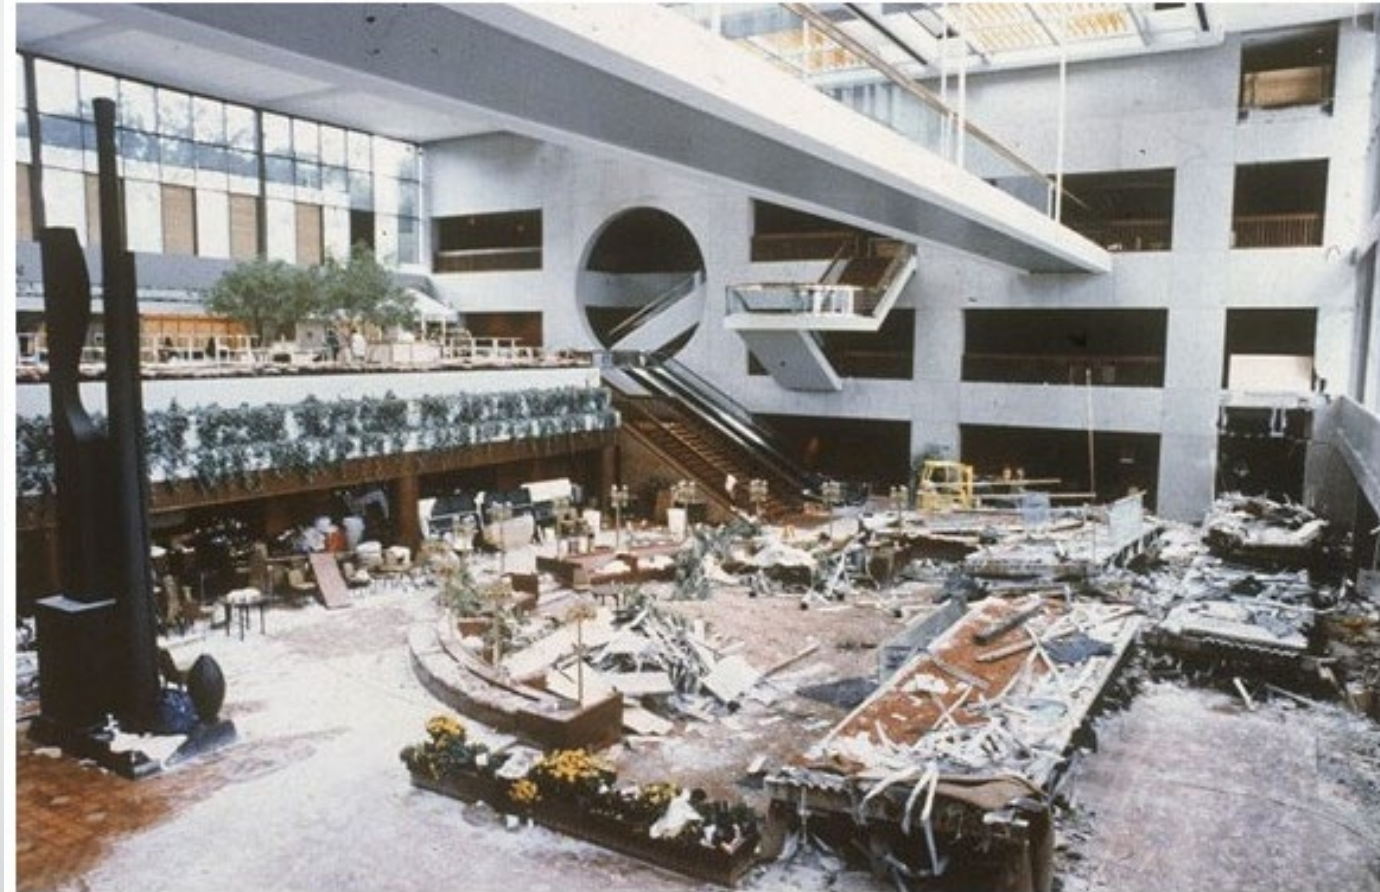
Hyatt Regency Hotel Walkways 1981

- 114 fatalities, 200 injured
- Causes:
 - Poor design
 - Redesign overstressed steel support rods
 - Fatigue details
 - Engineering Firm did not check field redesign
 - Overloaded walkways
 - Approval of drawings issues

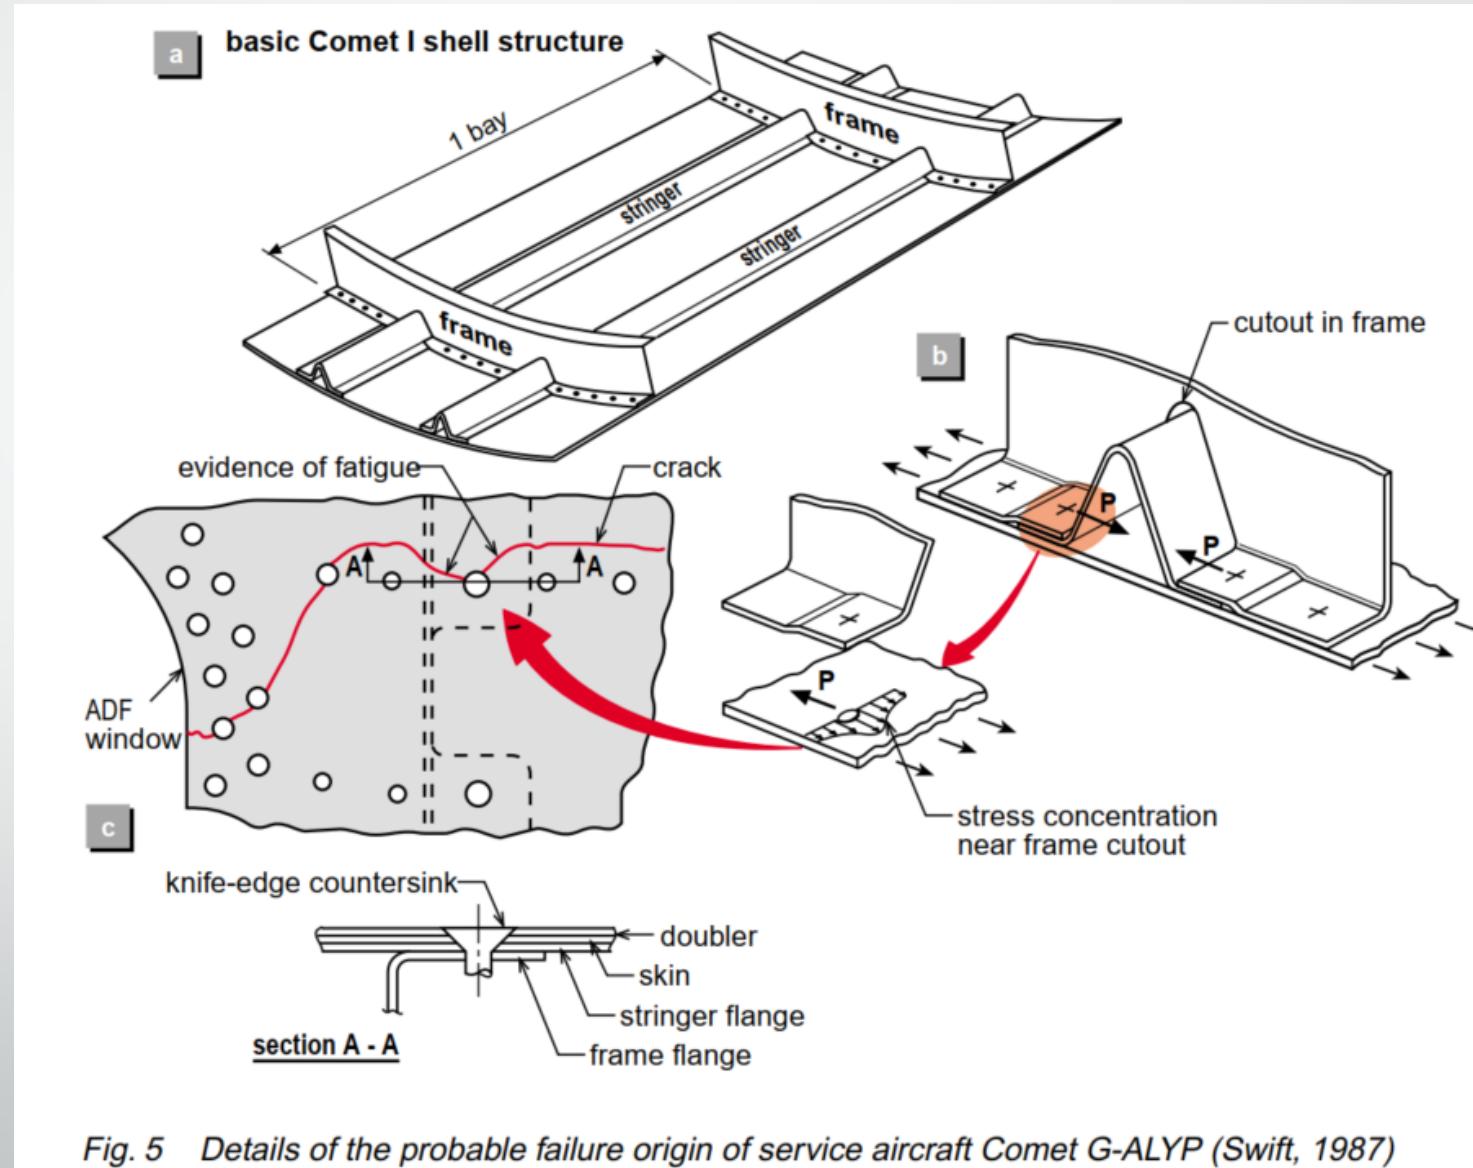
- Detail showing crack nucleation location
- Frame outer flange discontinuity creates high fastener bearing loads / concentration
- Causes:
 - Higher cabin pressure
 - Frame discontinuity raised notch stresses
 - Square corner navigation cutouts also raised stresses due to compound Kt superposition

Fig. 5 Details of the probable failure origin of service aircraft Comet G-ALYP (Swift, 1987)

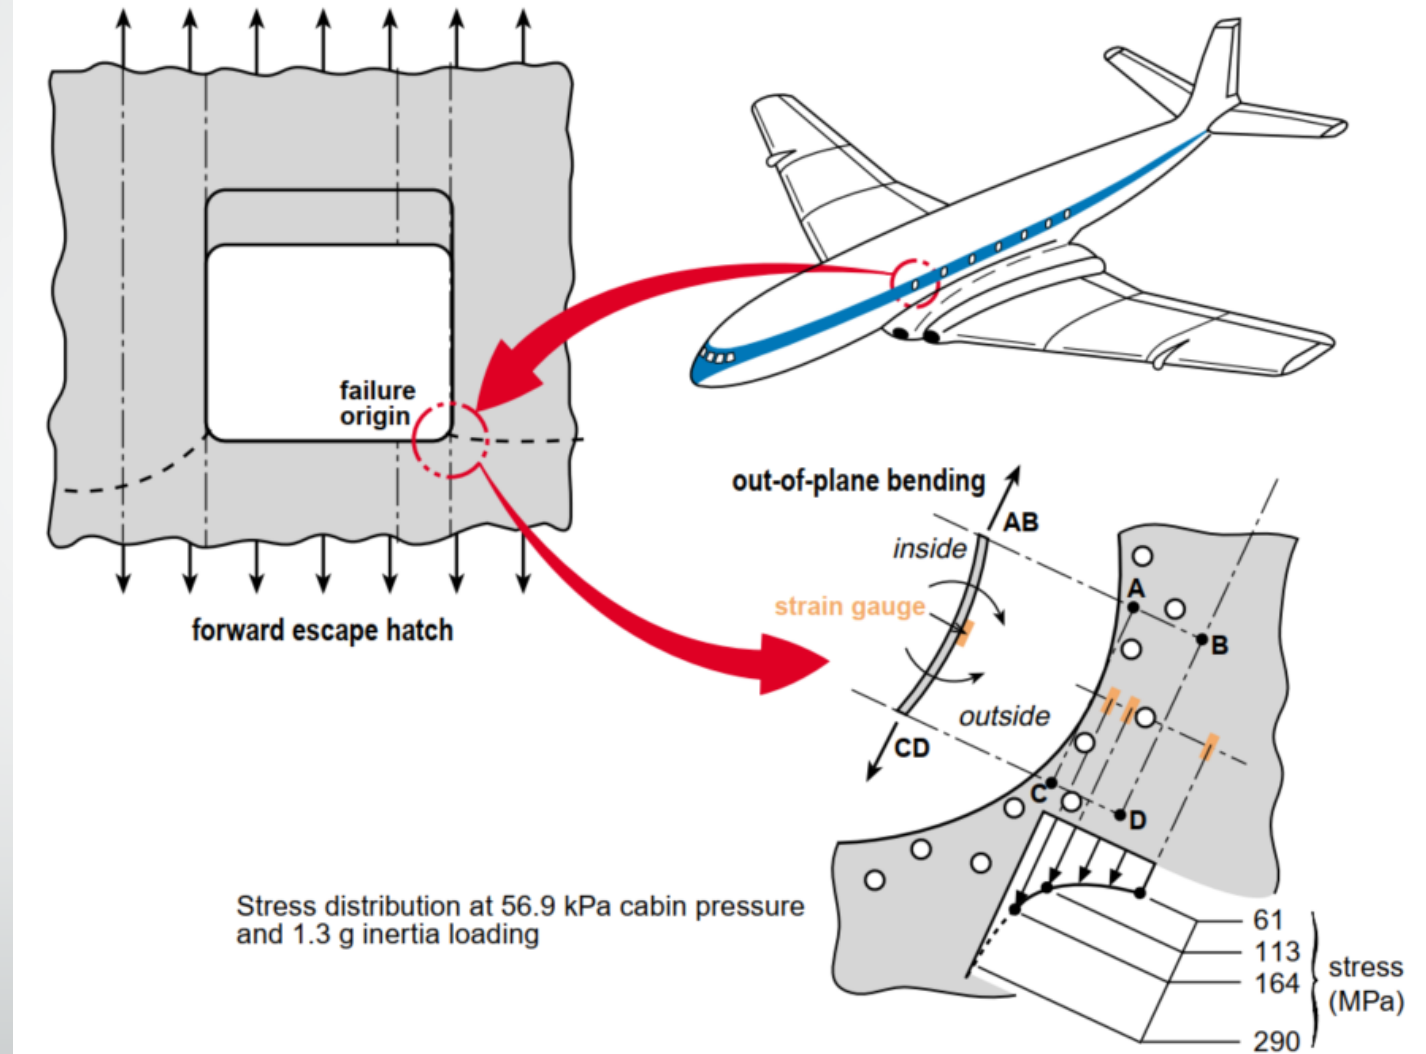
- Aircraft taken out of service and full scale pressure tested
- Test aircraft showed cracking in different locations
- 1.33 x Press proof loads were applied

Fig. 3 Probable failure origin of test aircraft Comet G-ALYU: stress distribution obtained after repair (Swift, 1987)

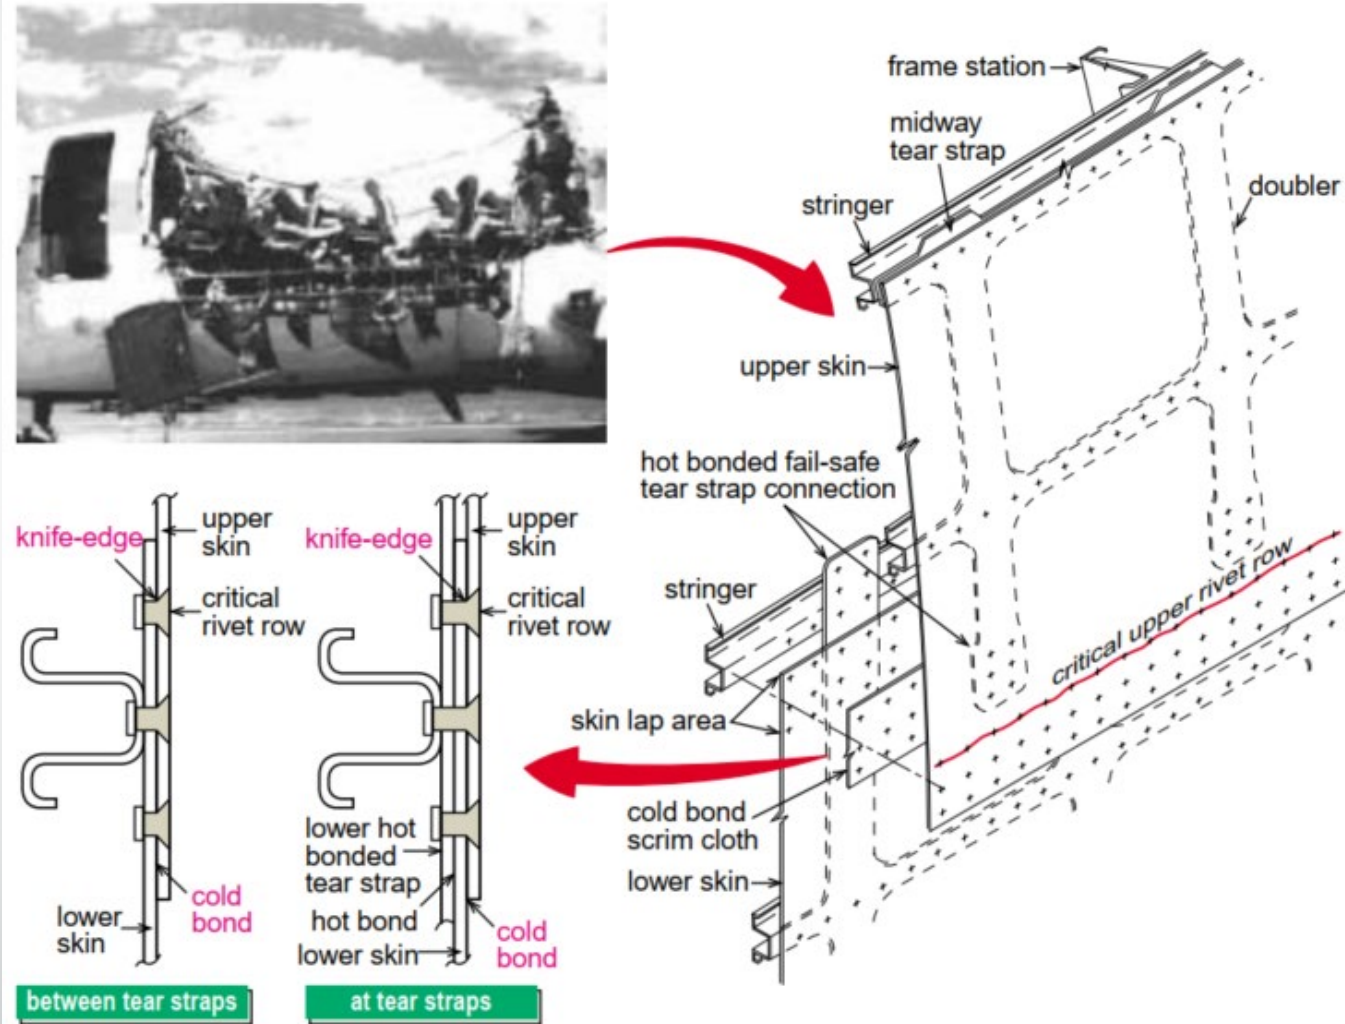
Aloha Airlines 737 - 1988

- Early 737
- 1 fatality
- Miracle landing
- Resulted in Aging Aircraft Pgm.
- Causes:
 - Poor loadpath design
 - Knife edge hole
 - Failsafe straps not long enough
 - Manufacturing difficulty
 - Poor Service Bulletin approach / enforcement by FAA
 - Poor maintenance program at Aloha
 - Corrosion prevention / detection
 - NDI training
 - Aircraft was inspected prior to failure
 - Stress intensity solution inadequate (crack interaction)

Fig. 8 Structural aspects of the Aloha Airlines Boeing 737 accident: Multiple Site fatigue Damage (MSD) occurred in the outer (upper) skin, commencing from the knife-edges of the rivet holes along the upper rivet row

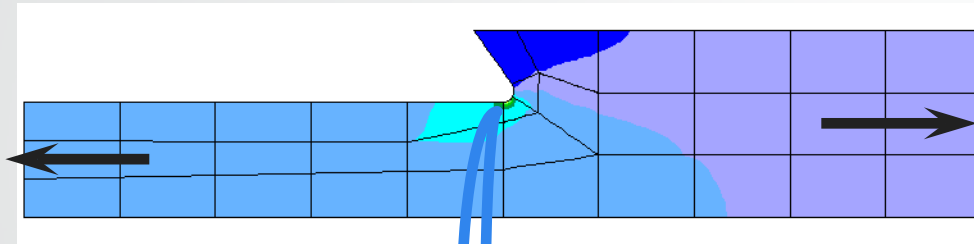
Max Stress Not at Notch Tangency where Crack Originated

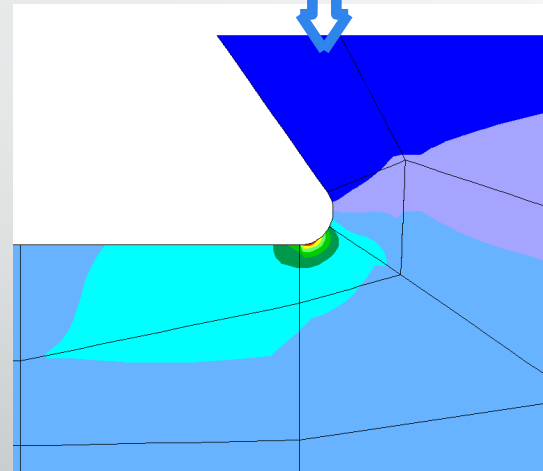
- This Type Geometry Notch Stresses Not Normally in Handbooks
- Handbook is only σ_1 not other terms σ_2 , σ_3

Score marks (machining mismatch marks) triggered early cracking

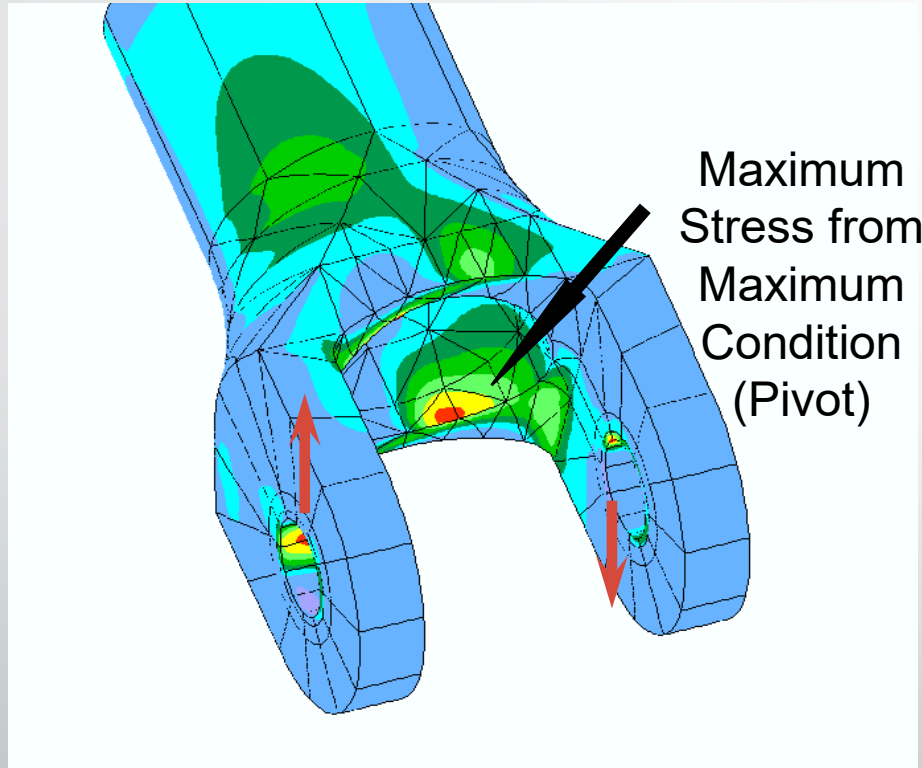
Difficult to analyze due to
complex loading and stress
response

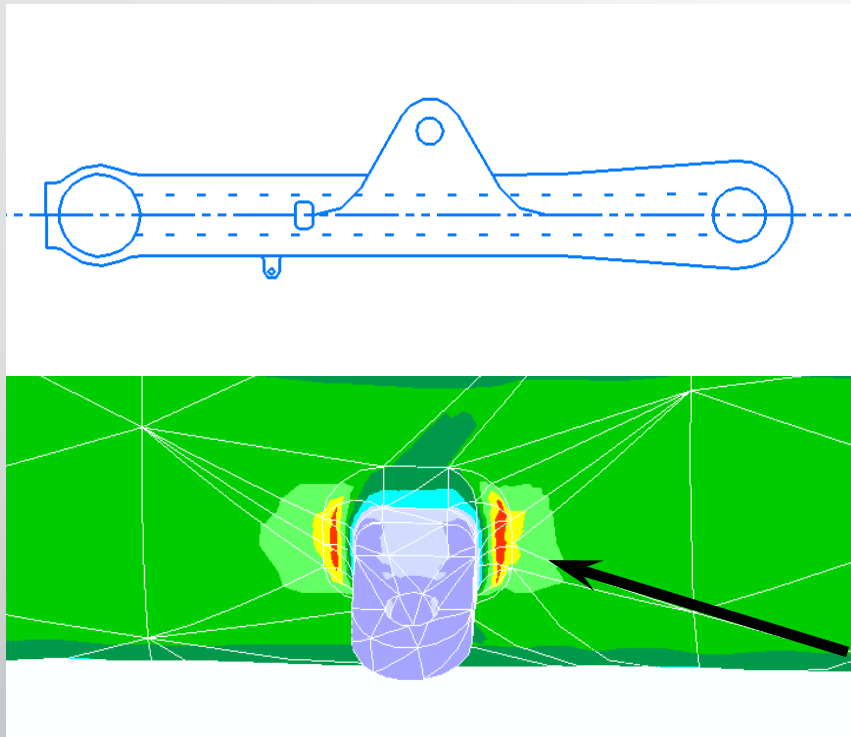
Design did not need lug in this location

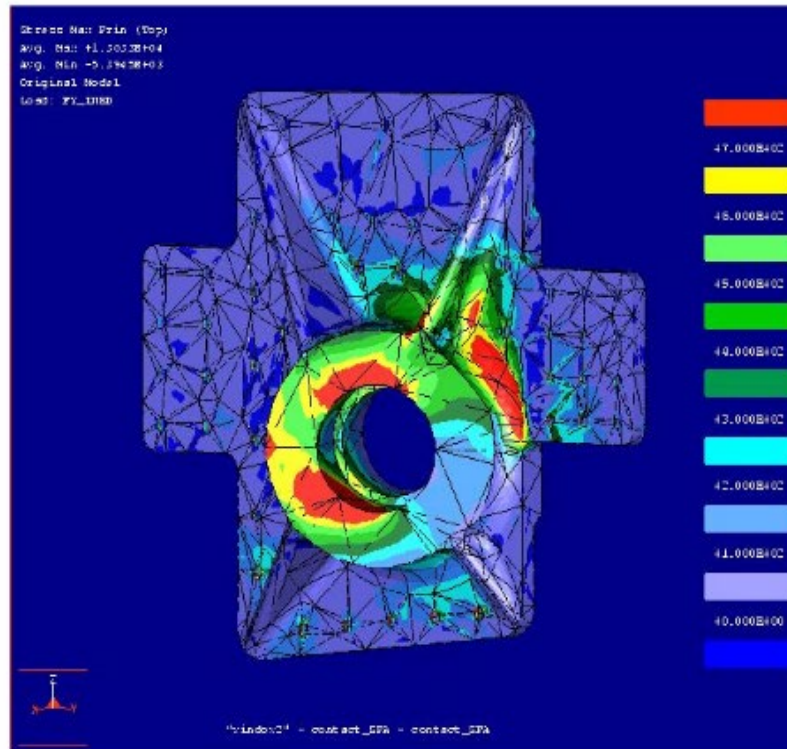
Complex part resulted in compound stress concentrations

- Part loaded in bearing
- 40 bolts modeled in contact

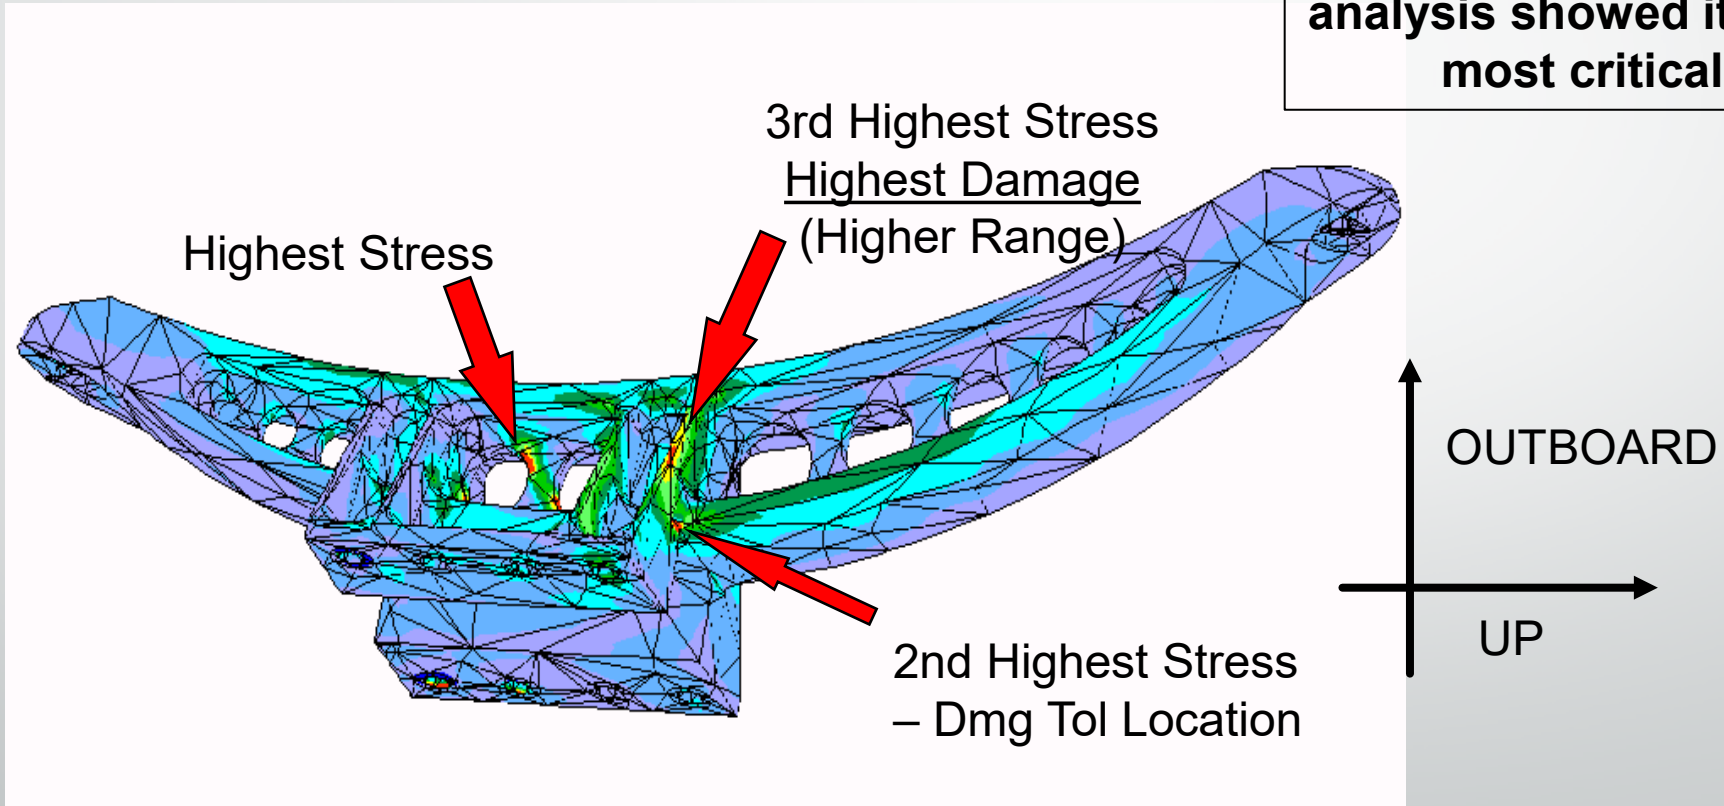
Part did not crack at damage tolerant location. Subsequent analysis showed it was not the most critical detail.

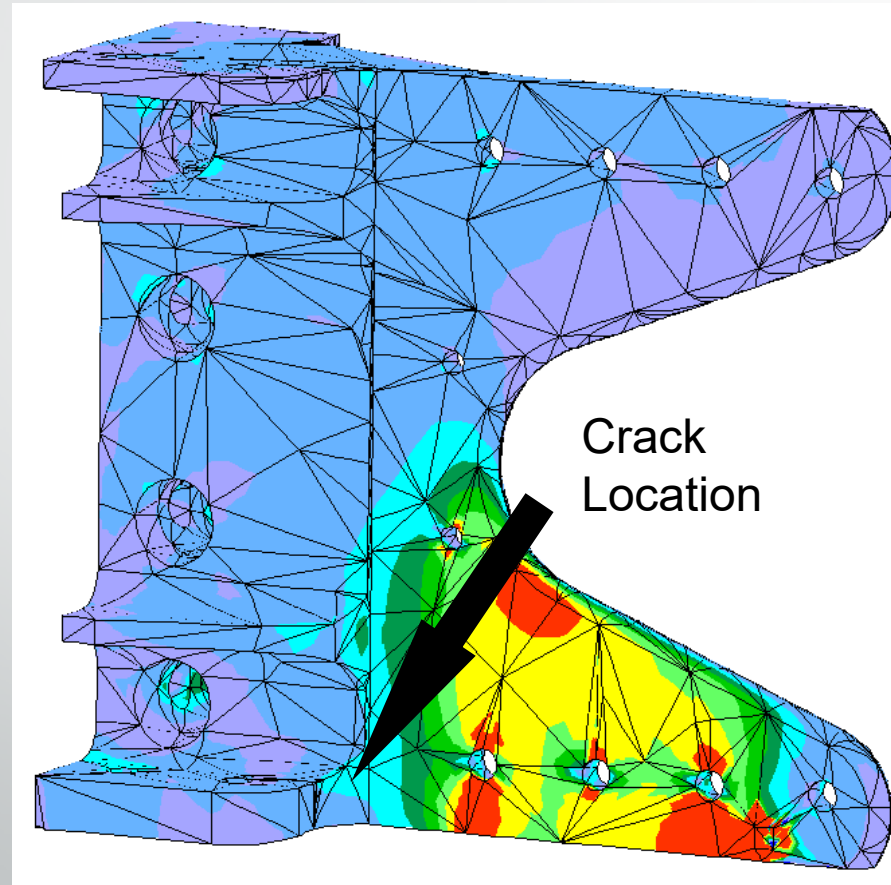
Part cracked due to test issues

- Full scale actuator controller failure
- Component test fixture design highly preloaded the article
 - Resulted in 14 orders of magnitude reduction in life

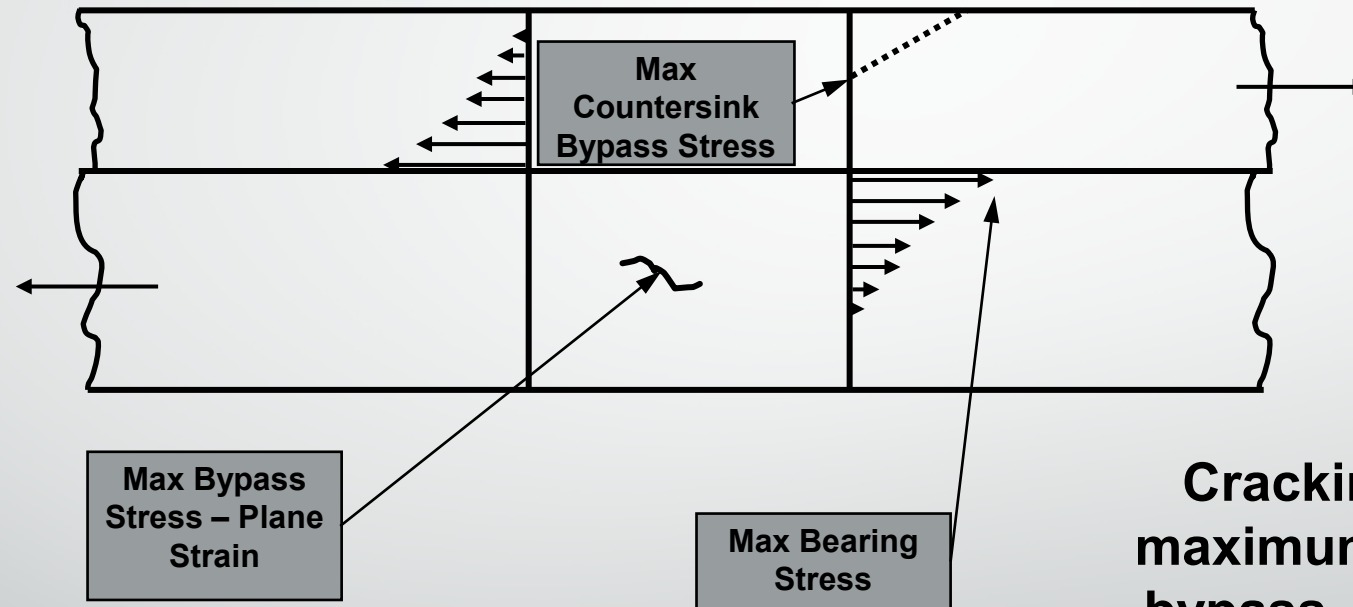
Cracking results from maximum combination of bypass, bearing, and / or bending notch stresses plus manufacturing effects like surface finishes

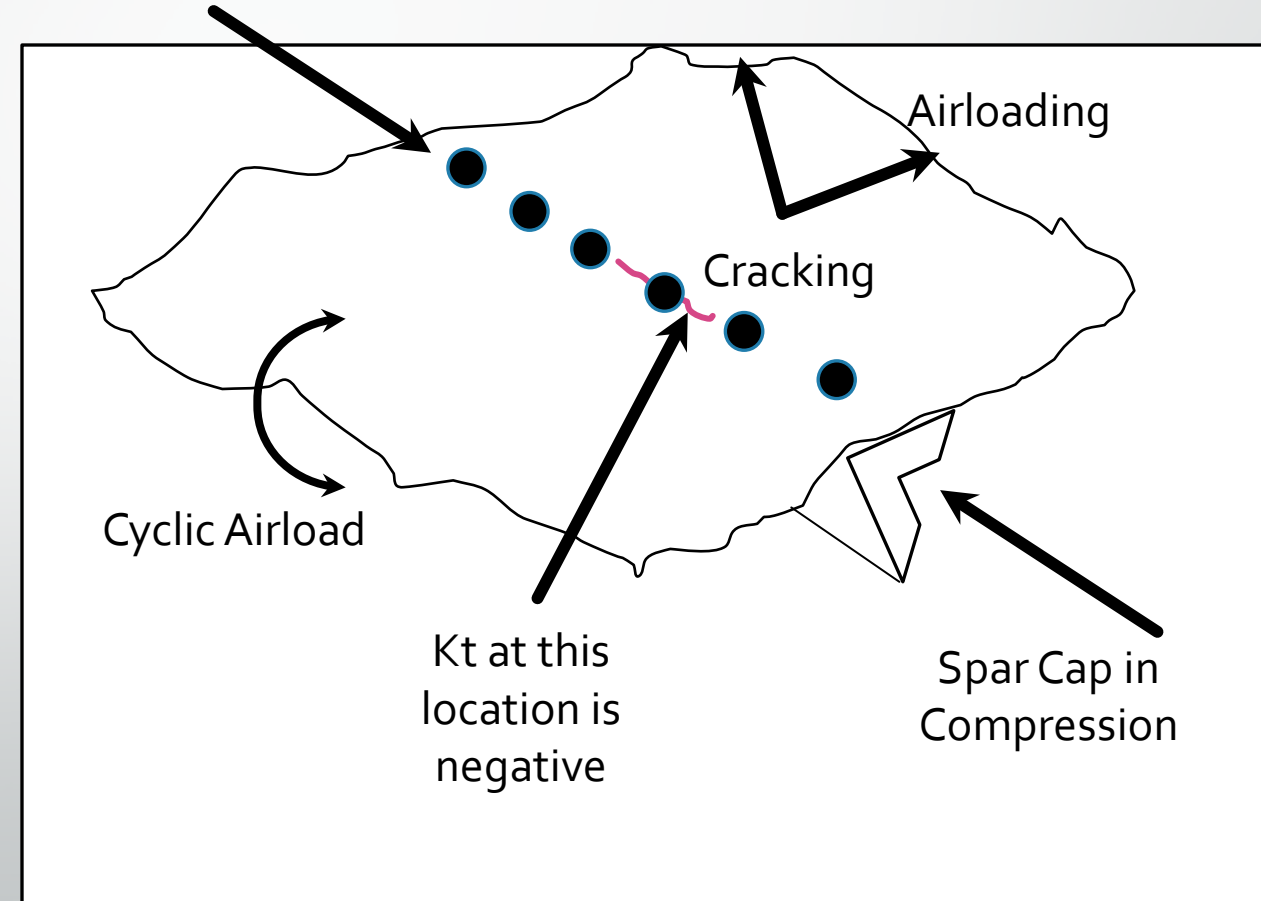
Horizontal Tail Upper Skin Cracking

- Know all aspects from the environment
 - 2 mean stresses
 - Source of sound loading
 - Flight load effect on damage location
 - Normal Pilot Operating Procedure
 - How does panel preload affect panel response
- Know source of data
 - Normal sonic fatigue test pressure perpendicular to panels
 - This pressure is flowing parallel to skin
 - Does the test panel alloy match?
 - Does the stiffener attachment / stiffness matter?
 - Normally, fatigue panels have straight shanked holes
 - These holes have knife edge

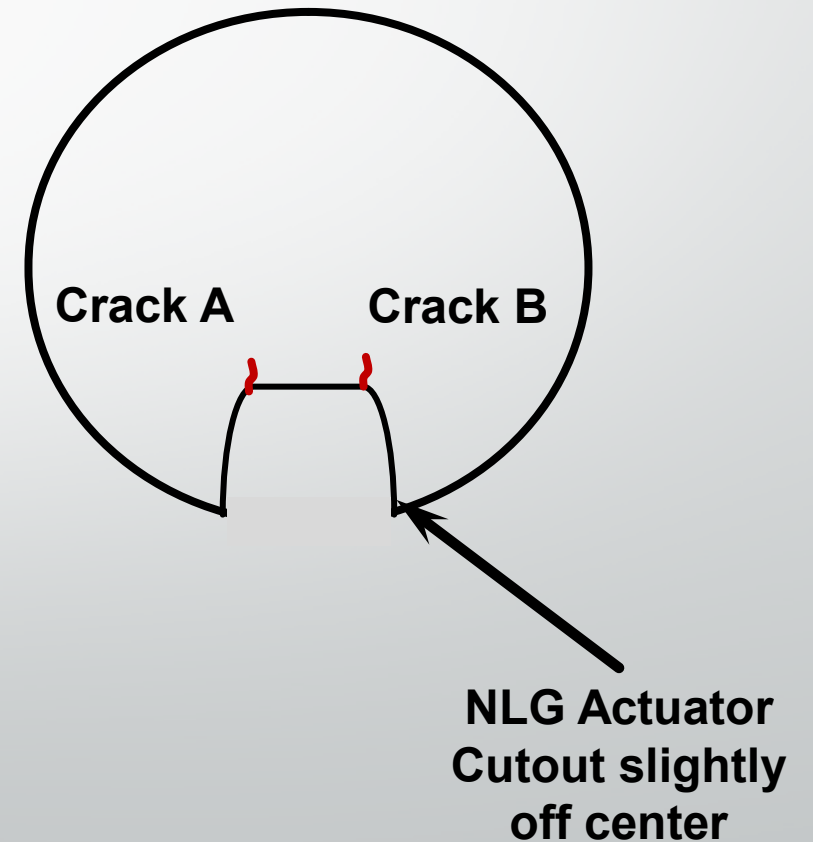
- Cyclic pressure test did not crack at nose gear actuator cutout
- Fullscale flight load + pressure test cracked in two radii
- Crack A cracked in 1/5 time of Crack B
- Subsequent analysis showed Crack A lower stress; Life should have been 8 times longer
- Surface Finish marks from deburring were different
 - Crack A sanded across thickness and rougher
 - Crack B was parallel to edge

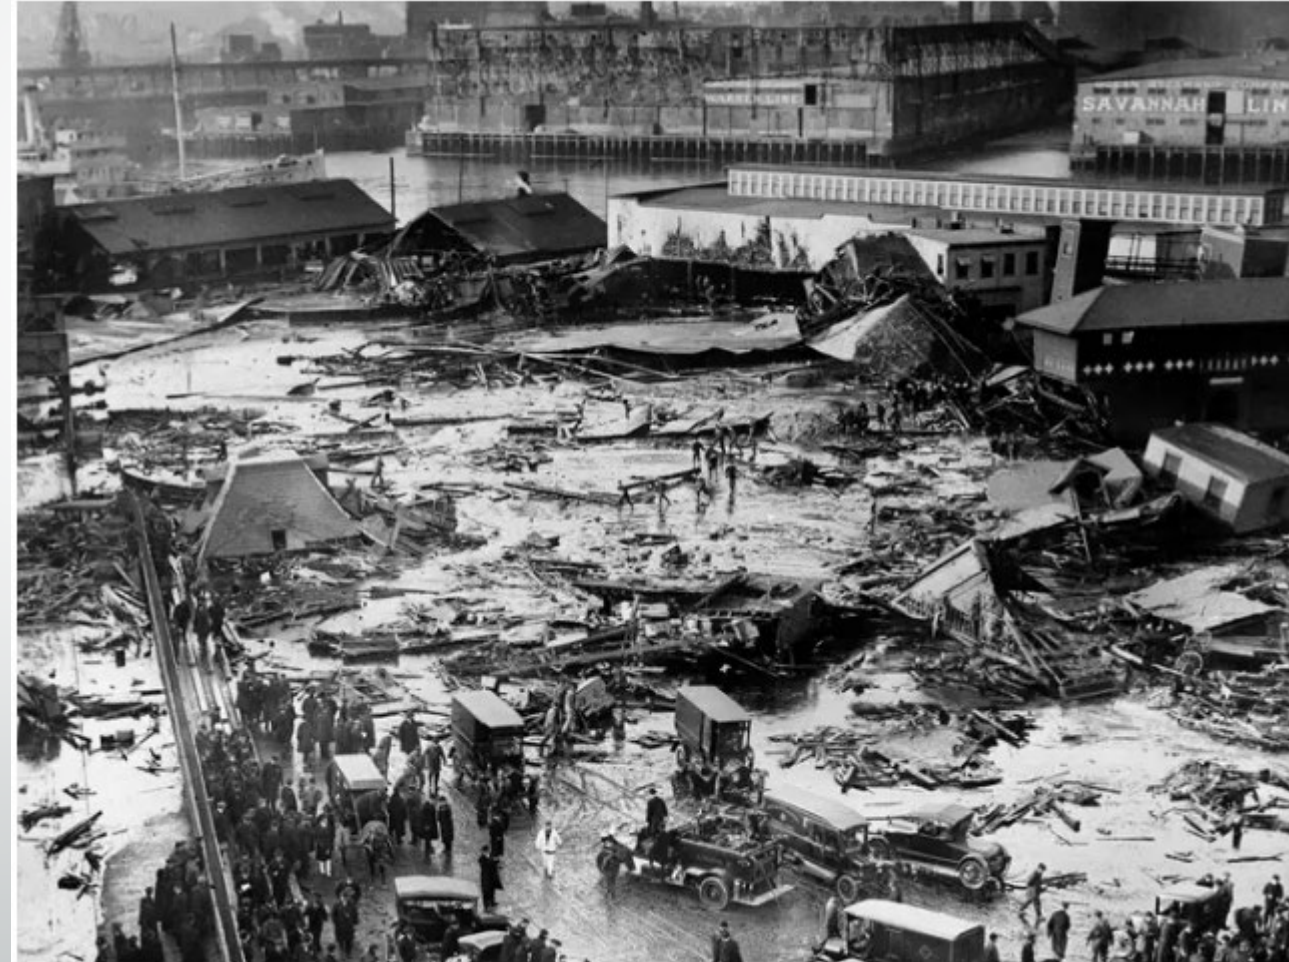
MOLASSES TANK(S) - 1919

- 2.3M gal molasses tank (50 ft high by 90 ft dia) ruptured, 15 Jan 1919
- 21 fatalities / 150 injuries plus many horses, buildings, etc.
- \$628K damages
- 25ft x 160ft wall moved at 35 MPH
- Causes:
 - Flaw at rivet hole; Poor quality construction
 - Brittle steel
 - Cold temperatures
- Resulted in birth of Fracture Mechanics - Griffith

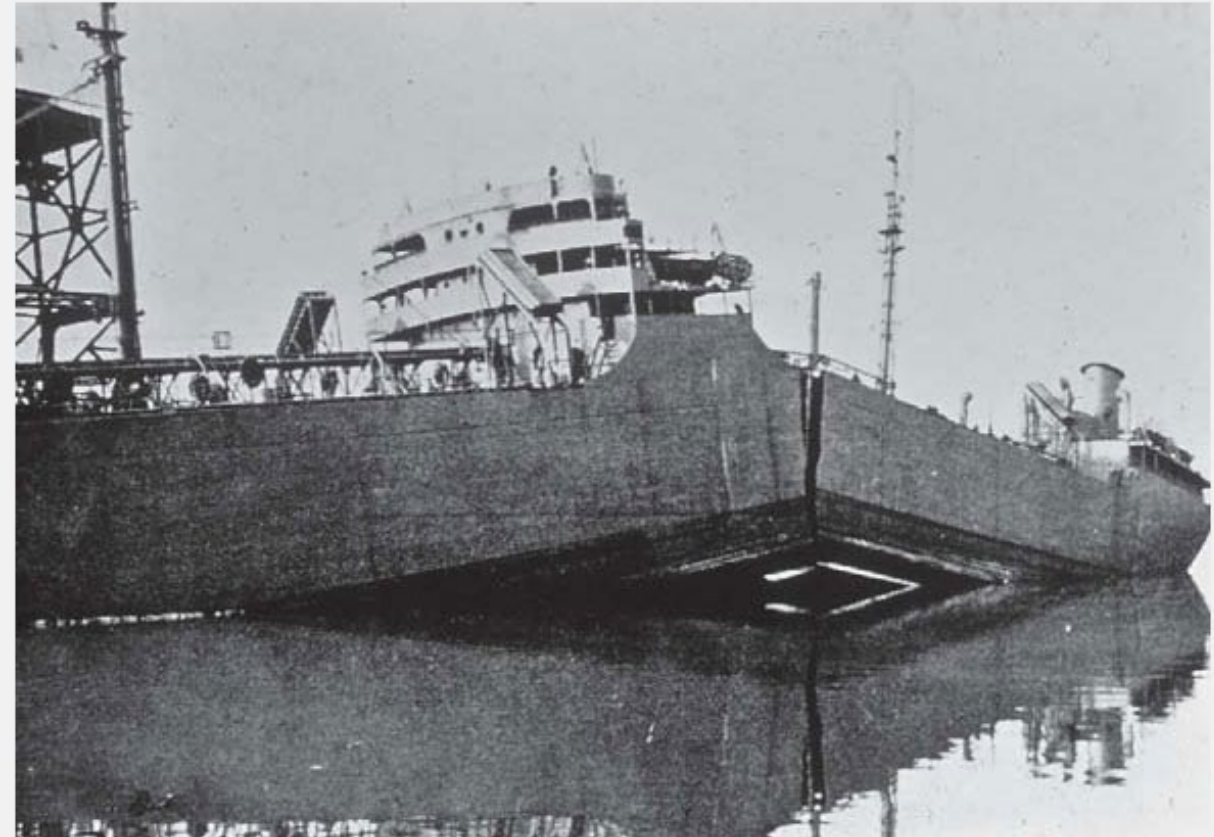
LIBERTY SHIPS DURING WW II

- 1500 brittle fractures in over 2700 ships; several sunk
- Some fractures were at the dock before fitting
- Causes:
 - Square hatch pass thru hull with sharp corners, not reinforced (until later)
 - Brittle, low toughness steel, very temperature sensitive
 - One ship hull was launched in afternoon and next (cold) morning ship was fractured at dock
 - Inexperienced welders working rapidly to complete ASAP
 - Record was hull launch 5 days after keel laid
 - Uncalibrated welding procedures
 - Residual stresses and lack of fusion flaws in the welds

The Liberty ship S.S. Schenectady, which, in 1943, failed before leaving the shipyard. (Reprinted with permission of Earl R. Parker, Brittle Behavior of Engineering Structures, National Academy of Sciences, National Research Council, John Wiley & Sons, New York, 1957.)

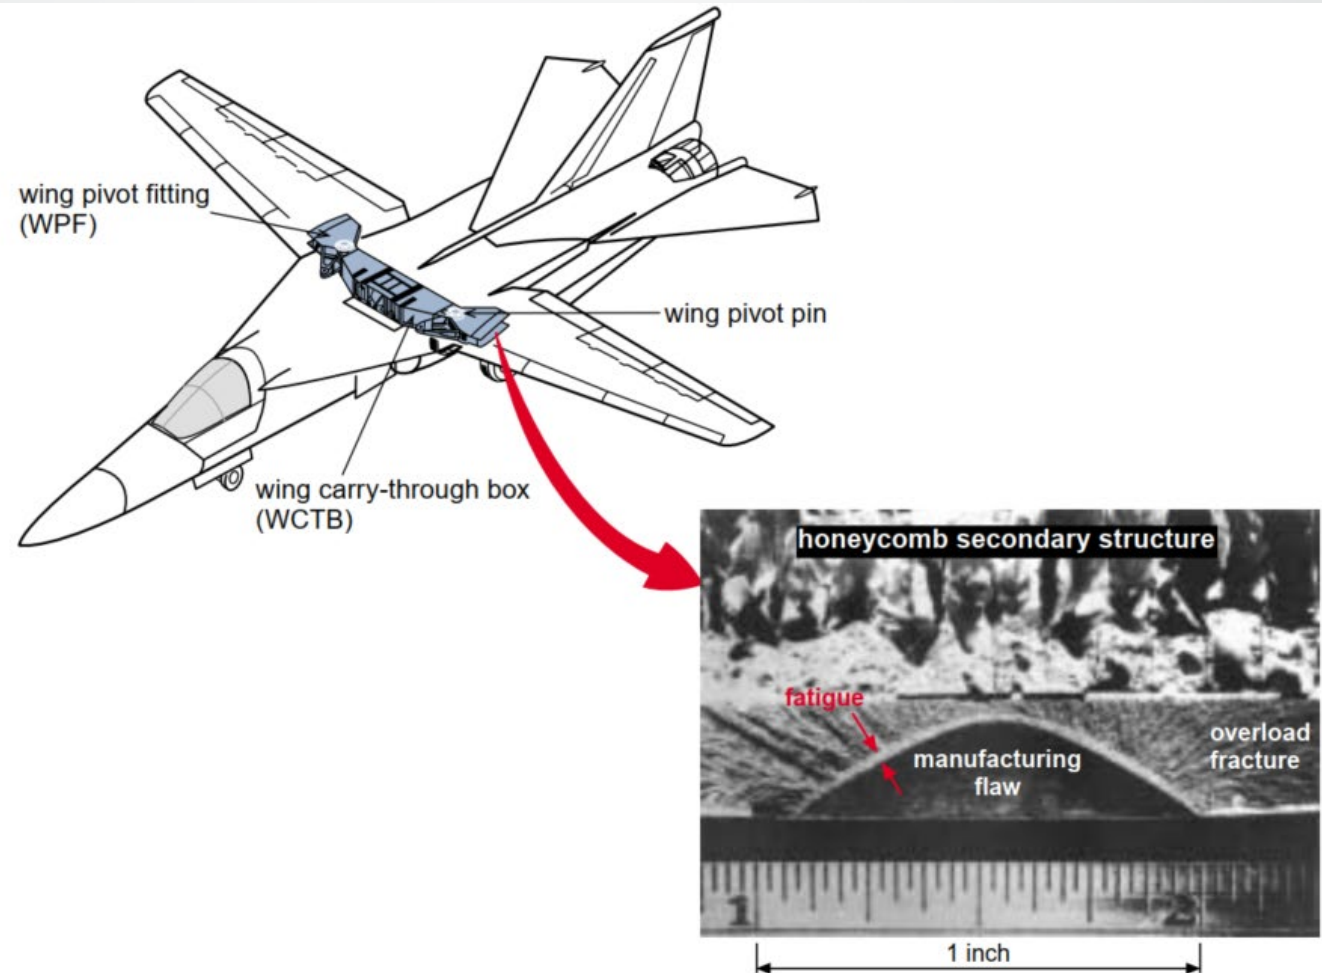
F-111 WING PIVOT FITTING - 1969

- 107 airframe hours
- Not only one failure; several fatalities
- Causes:
 - Fold in forging 1" x 0.38"
 - D6AC steel not damage tolerant (low toughness)
- Directly responsible for USAF ASIP Damage Tolerance Program

Fig. 6 Failure origin of F-111 #94: a manufacturing flaw in the high-strength steel lower plate of the left-hand wing pivot fitting

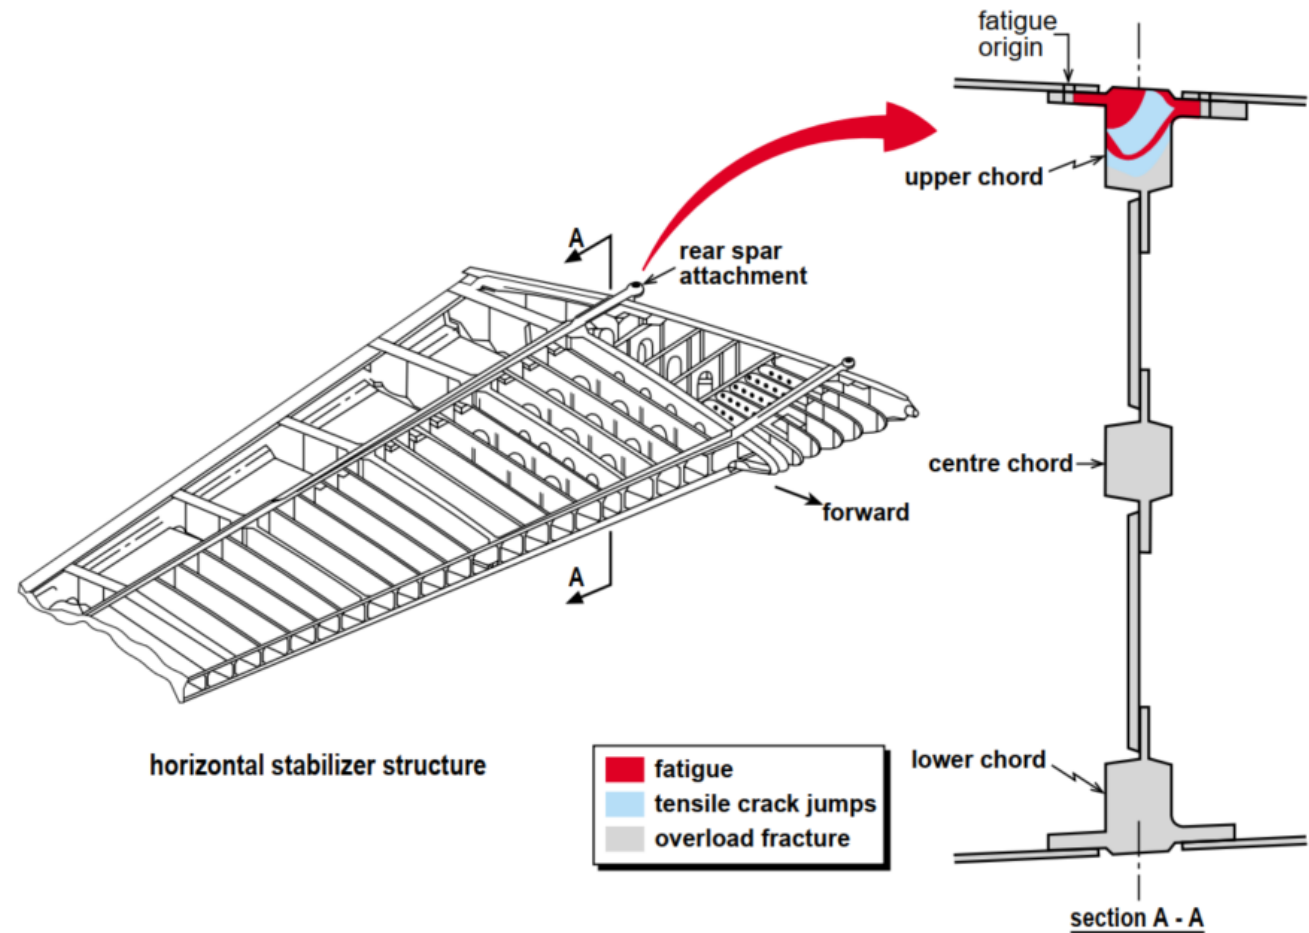
Dan Air 707 Horizontal Tail - 1977

- 707-300 formerly in service with British Airlines
- Failed on approach Lusaka, Africa; 6 fatalities
- 47K flight hours (Design Goal – 60K)
- Causes:
 - High load transfer skin joint
 - High aft loads to elevator rib
 - High engine buffet loads on landings
 - Failsafe test not sufficient
 - No Damage Tolerance inspection program

Fig. 7 Failure origin of the Dan Air Boeing 707. After Howard (1986)
