OVERVIEW OF SELECTED STRUCTURAL FAILURES

Ric Leist, PE

15 June, 2023

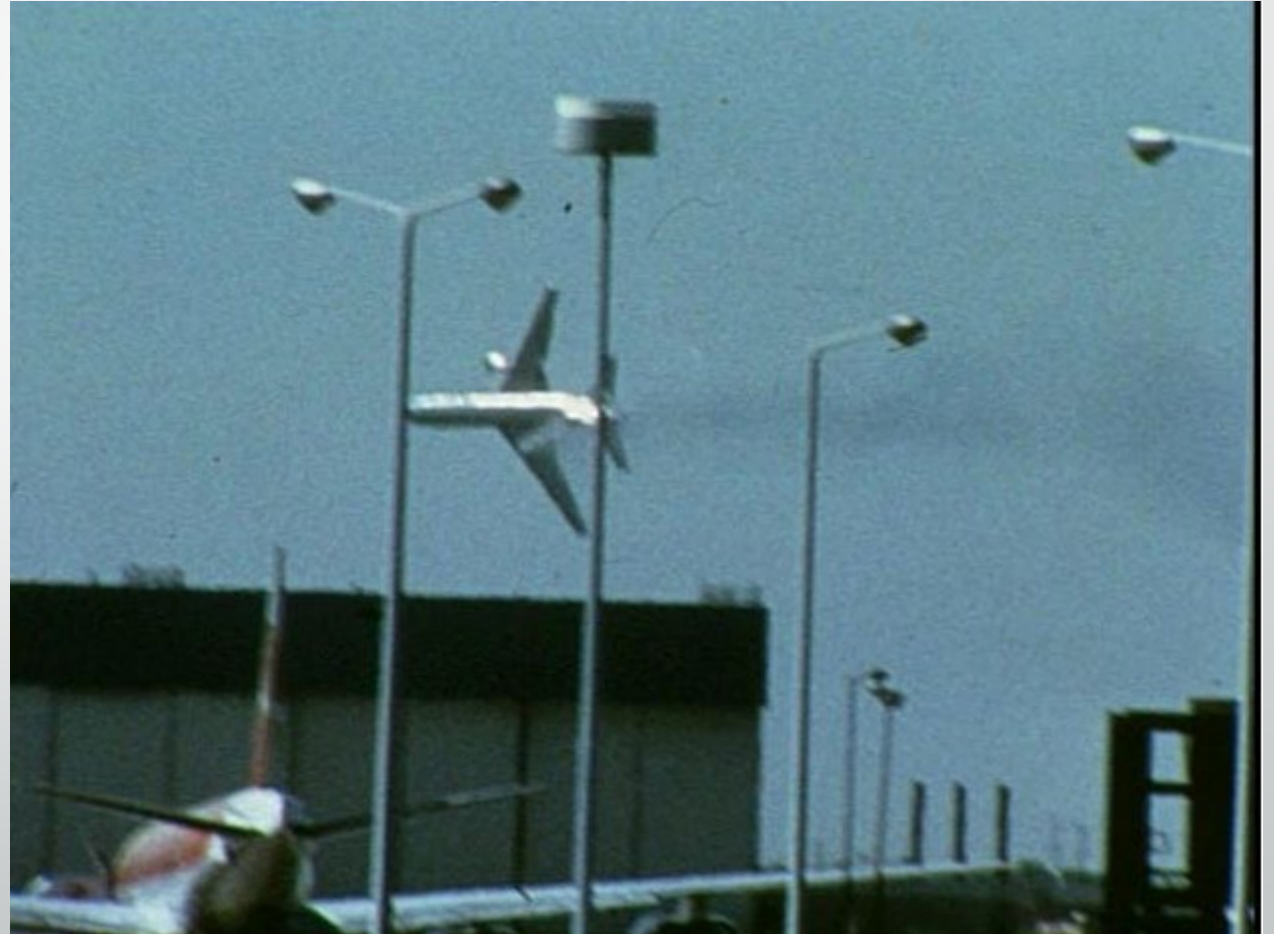
American Airlines Flight 191 - 1979

- 271 fatalities; no survivors
- LH Engine separated on takeoff in CHI
- Causes:
 - Maintenance induced crack grew for many flights before failure
 - Inspected 3 times without detection; difficult inspect
 - Design placed hydraulics in front of wing front spar for ease of maintenance
 - Engine/pylon separation was designed to roll over top of wing
 - Fwd pylon held too well, crushing hydraulic lines, retracting all LH wing flight control surfaces

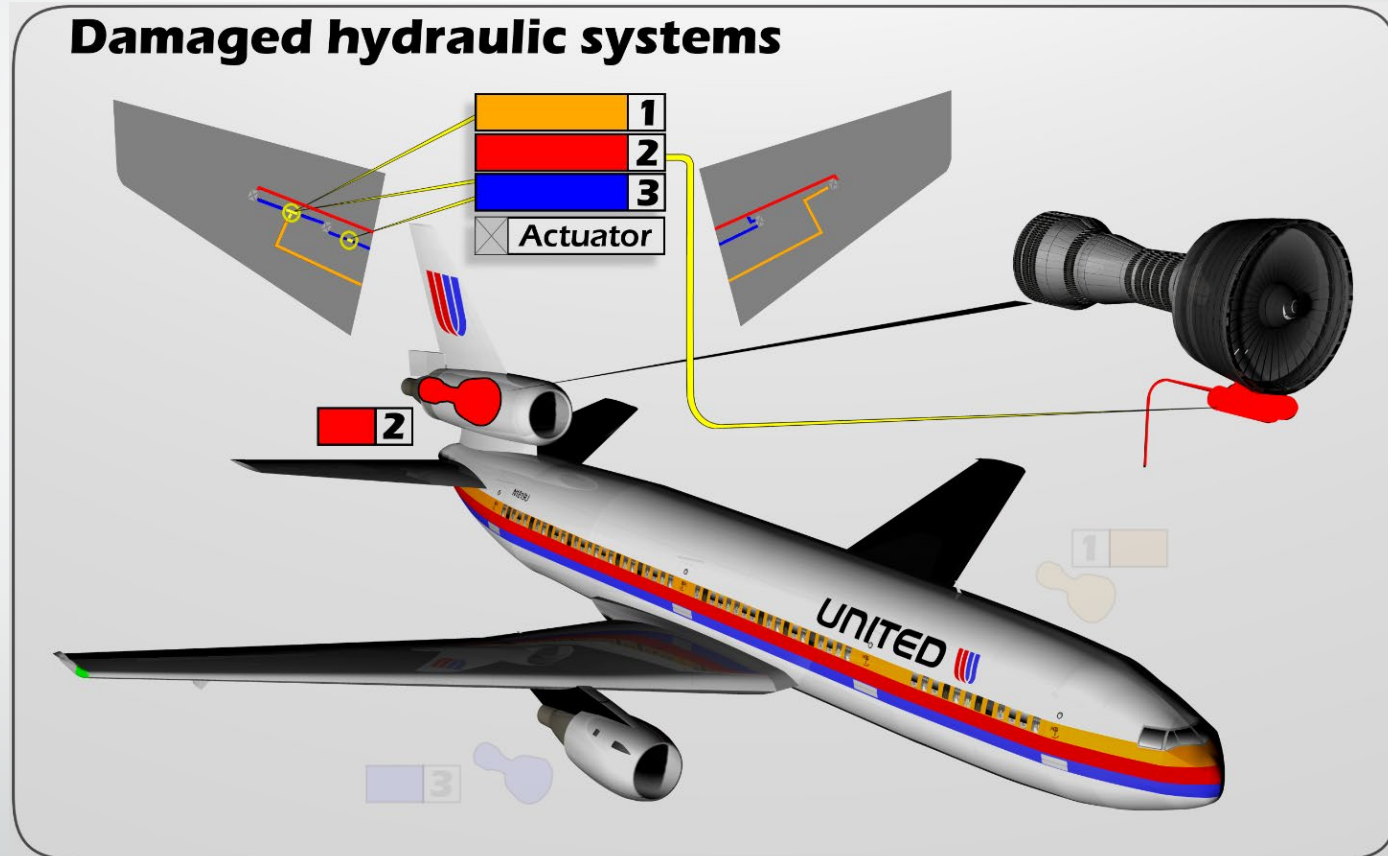
United Airlines Flight 232 - 1989

- 112 fatalities; 171 injured; 184 survived
- Failure of Stage 1 tail mounted engine disk
- Severed all three hydraulic systems in engine / horizontal tail
- Cause:
 - Maintenance procedure did not report fatigue crack growing from a manufacturing defect in the disk forging during manufacture
 - Damage Tolerance Procedures not followed

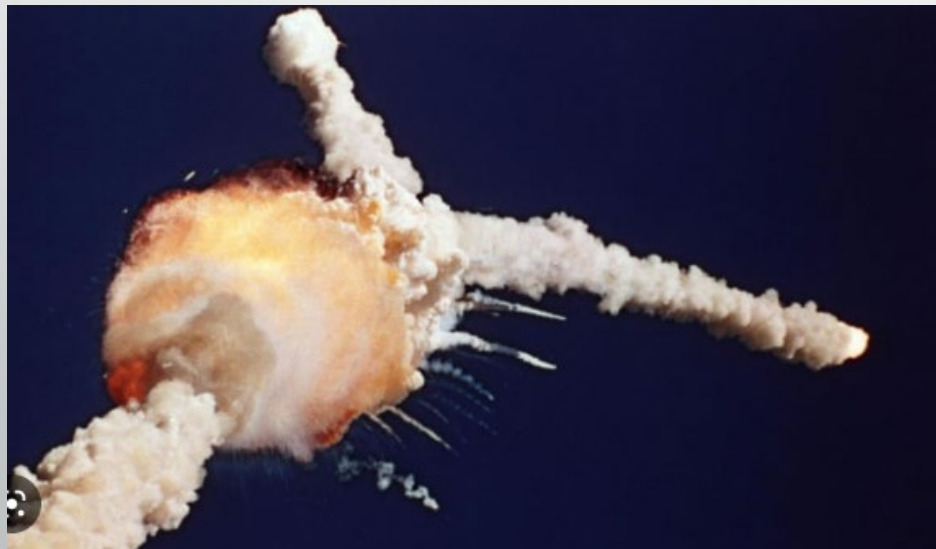
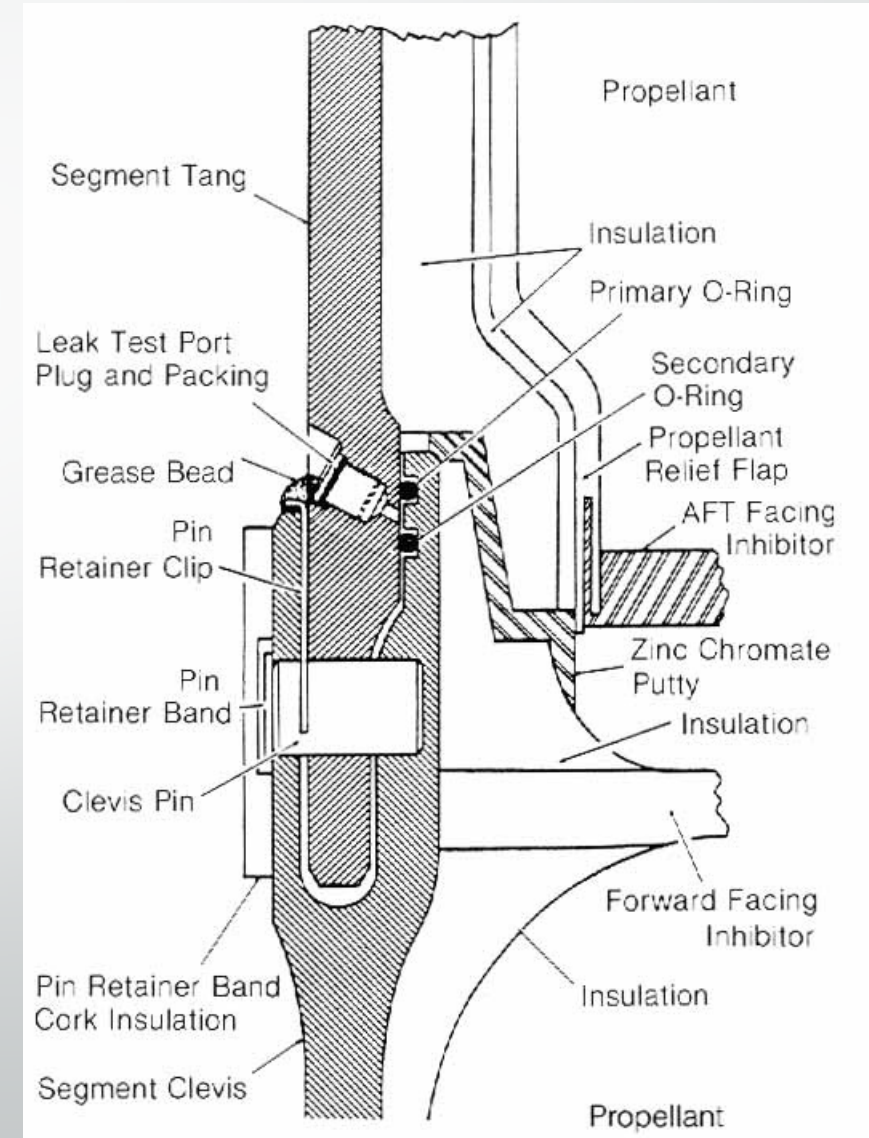
Challenger Space Shuttle, 1986

- Excessive tolerance in design allowed O-rings to gap, allowing burning fuel blow-by, O-ring erosion (known for several years)
- Failure:
 - Morton Thiokol engineers warned about issues as did NASA engineers
 - Erosion, design tolerance, and cold weather allowed joint to catastrophically fail on launch
 - Another failure was excessive personnel turnover in SRB assembly at Cape Kennedy (low salaries)

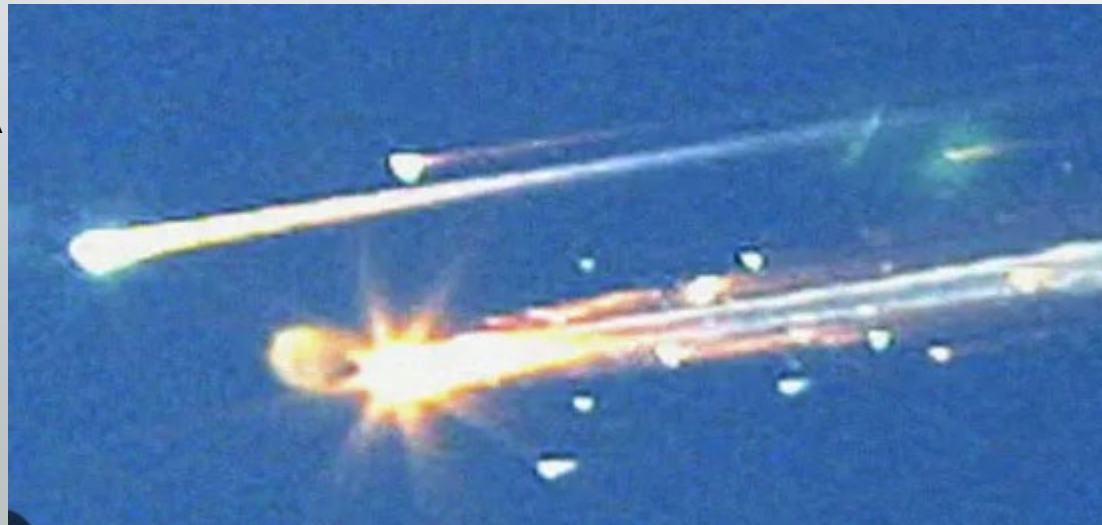
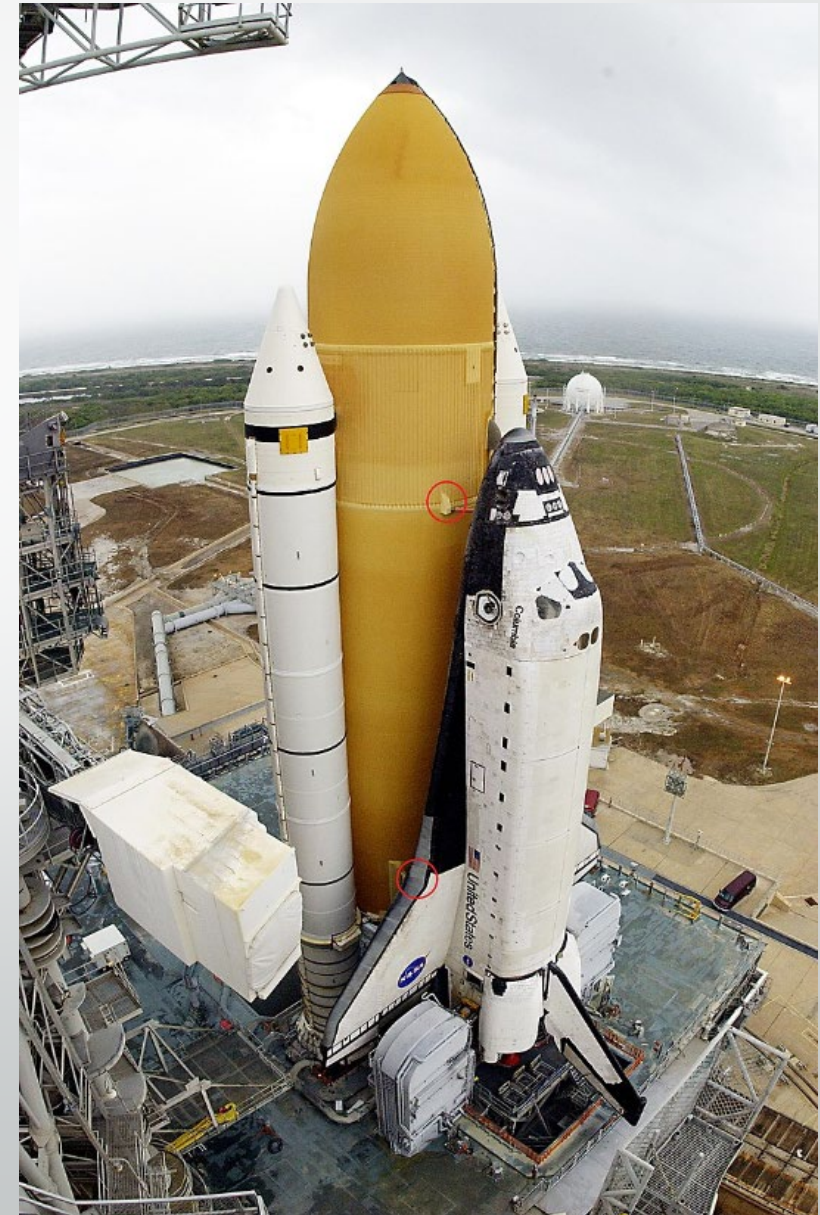
Columbia Space Shuttle, 2003

- Circled areas show where insulation failed and where it struck the shuttle wing
- Failure:
 - Disbonded insulation could not be detected.
 - No process to repair damage in Mission.
 - Impact to LH wing LE damaged heat shield which progressively overheated the substructure on re-entry until wing failure occurred.
