# **Voyager 1 & 2: Humanity's Most Distant Explorers**

## **Oklahoma Engineering Conference June 16, 2023**

Todd J. Barber (Voyager Propulsion Engineer)  
Slides Shamelessly Stolen from Suzy Dodd (Voyager Project Manager)  
Jet Propulsion Laboratory/California Institute of Technology

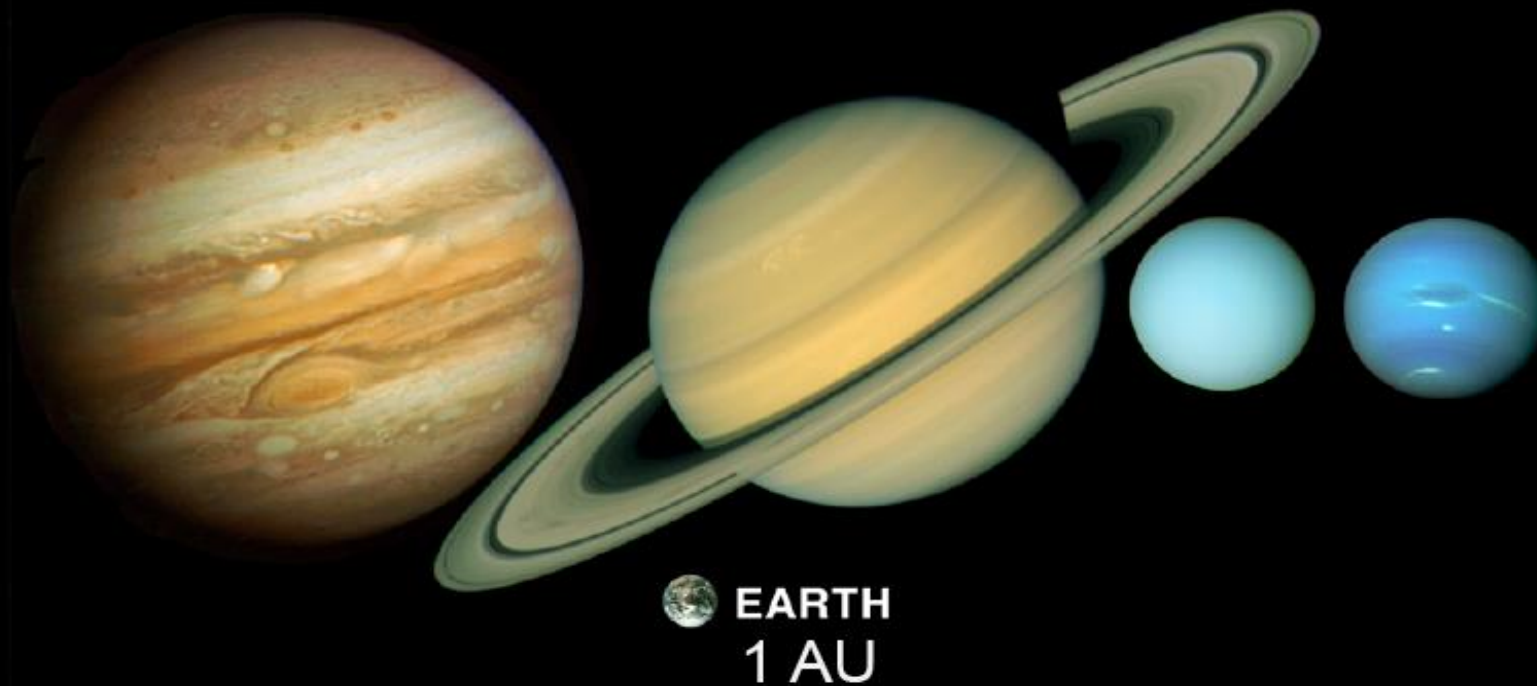
JUPITER  
5 AU

SATURN  
10 AU

URANUS  
19 AU

NEPTUNE  
30 AU

1 AU = 150 million km (93 million miles)
